### Experimental study on progressive collapse resistance of steel frames under a sudden column removal scenario

# Experimental study on progressive collapse resistance of steel frames under a sudden column removal scenario

**Abstract:** A comprehensive experimental apparatus for the progressive collapse testing of steel frames has been developed. The apparatus is suited for the testing of planar steel frames to study the load transfer process and the progressive collapse resistance of steel structures under a column removal scenario. In order to simulate a sudden removal of a middle column at the ground storey of the frames, a removable column unit has been designed to allow for an instantaneous knock-out by a pendulum hammer during the test. To avoid the out-of-plane instability of the planar steel frames, an out-of-plane restraining system has been designed and integrated into the test apparatus. Weights simulating the desired gravity loads were attached to the test frame through holding baskets, which were designed to minimize unwanted shaking and ensure that the suspended baskets moved together with the deformed steel frames during the tests. Experimental results showed that

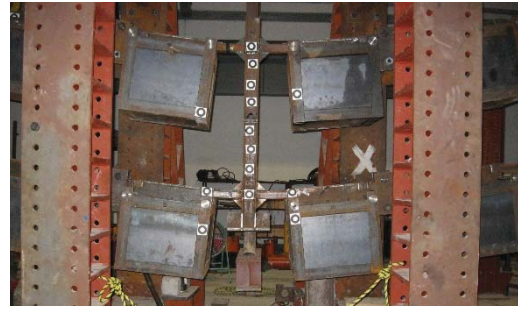
Fig. 17 Permanent deformation profiles of test frames

Fig. 17 shows an overall view of the deformed shapes of the steel frame specimens after the removal of the middle bottom column. FRAME 1 and 3 exhibited large permanent deformations, whereas FRAME2 (the strong beam-weak column frame) effectively failed as the columns adjacent to the removed column failed in bending and compression.

a. FRAME1

b. FRAME3

c. FRAME2 (middle and right photos show damages of columns)
